Feasibility Study of Using Composite Materials for Traction Motor Bearings

LTR-SMPL-2003-0223

August 2003

Prepared for
Transportation Development Centre
of
Transport Canada

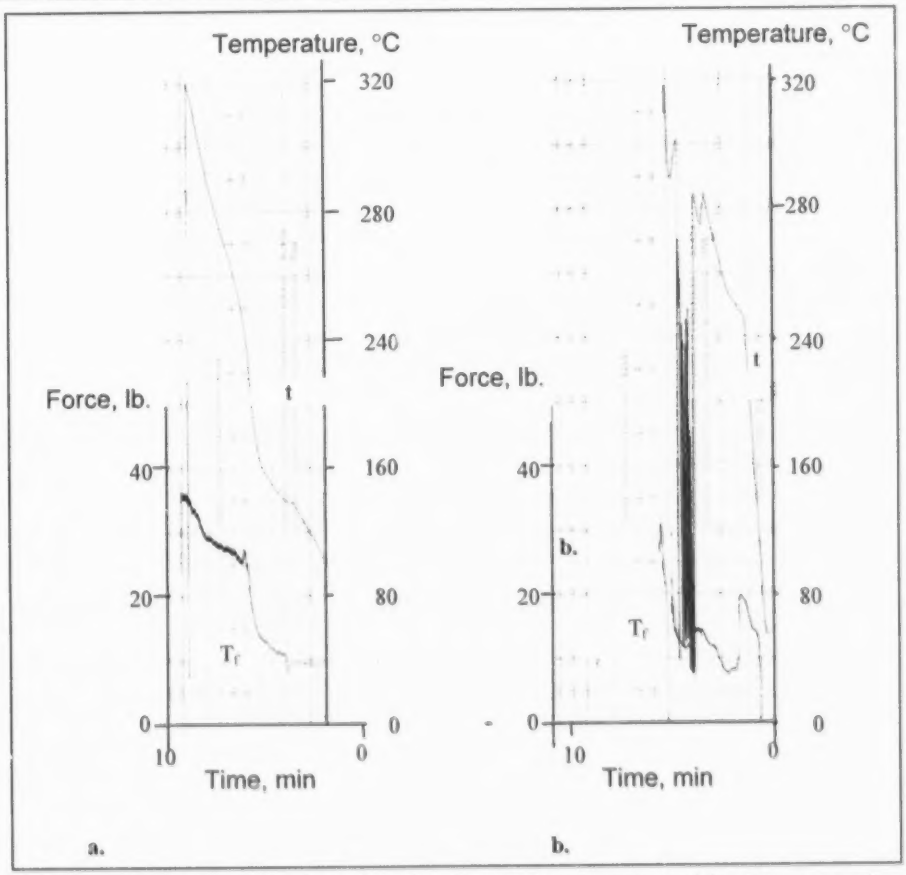
A summary of the test results is presented in Table 3. Three of the test materials did not perform satisfactorily at all test conditions. Examples of data collected from the failed tests on the DP4 and Vespel® SP21 materials are shown in Figure 5. Rapid growth of both the block's temperature and friction force terminated the test.

Figure 5 **Data from the failed tests: T_f - friction force, t - block temperature**
a. DP4, 0.392 kN (88 lb.), 732 rpm
b. Vespel® SP21, 0.154 kN (35 lb.), 3170 rpm

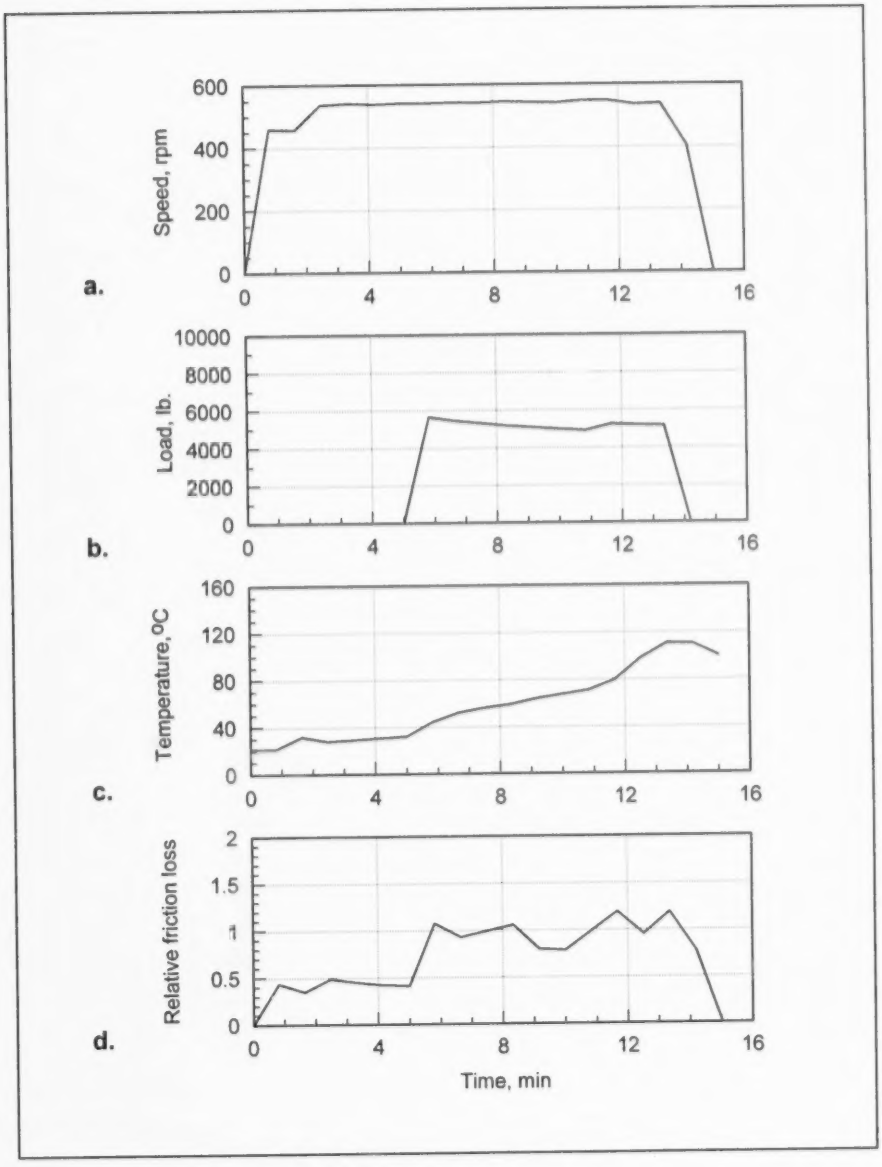
Tests on the first Vespel®-lined bearing were not concluded successfully. The bearing failed after only 11 minutes of operation, when the shaft speed was 538 rpm and the bearing load was 5000 lb. Figure 18 shows the main test parameters plotted against time (friction loss is related to the average loss for the load of 5000 lb.). At the time of the failure, concern was expressed about the large amount of torque applied to the housing bolts during the assembly procedure. This puts a high hoop strain on the bearing. While this is an acceptable practice in the case of the conventional bearing, it was speculated that this might have caused the Vespel® rings to separate from the brass backing.

Figure 18 Test results. Mark 1 Vespel®-lined bearing

a. shaft speed **b.** bearing load

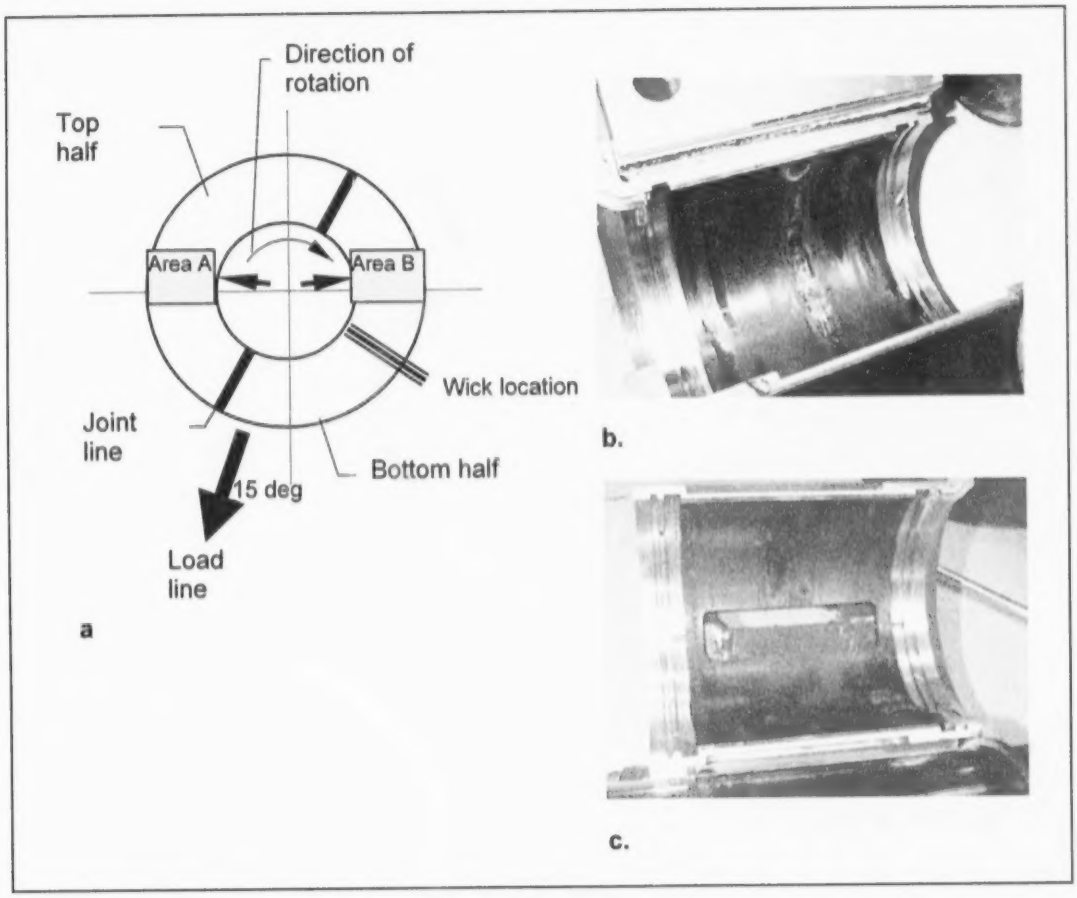
Figure 19 shows the heavily rubbed areas and their location in relation to the load line. The shaft after this test is shown in Figure 20.

Figure 19 **Mark 1 Vespel®-lined bearing after failure**
a. damaged sites **b.** top half **c.** bottom half

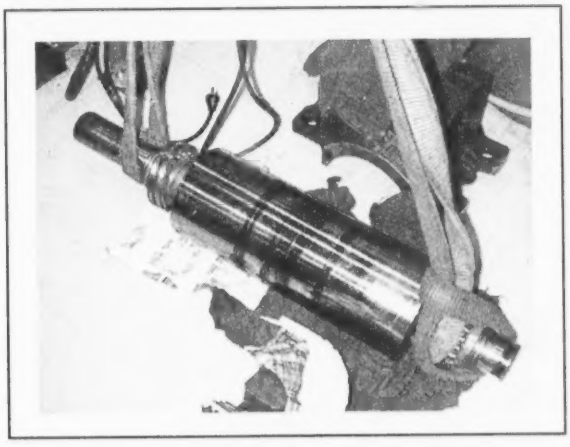
Figure 20 **Shaft after failure of the Mark 1 Vespel®-lined bearing**

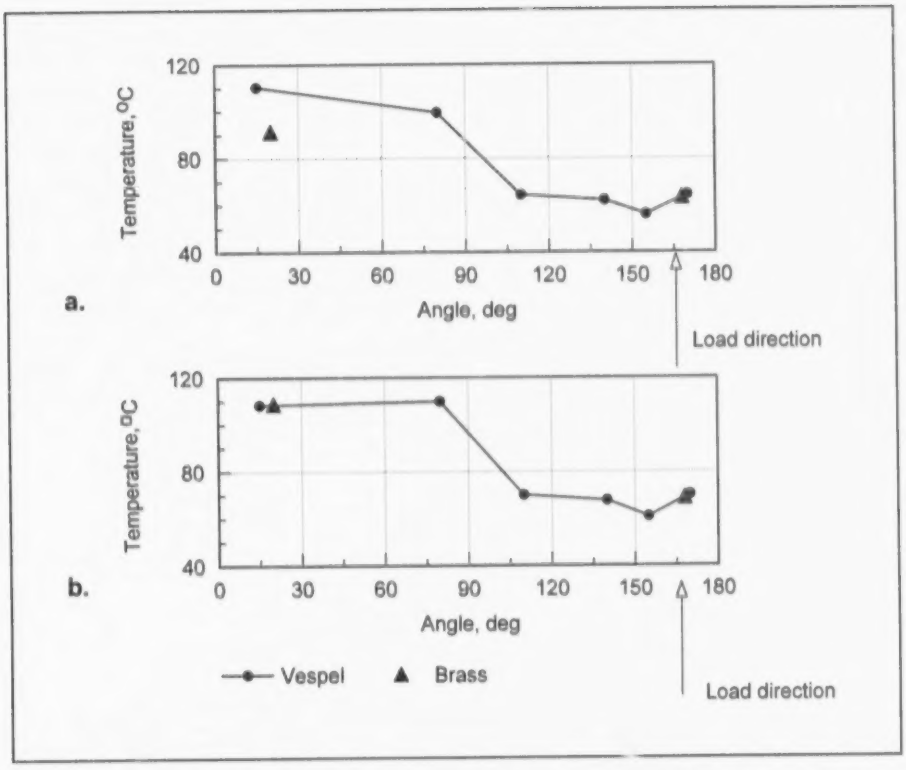
Figure 21 **Centre line temperature profile: Mark 1 Vespel®-lined bearing**
a. at time of failure **b.** immediately after removing 5000 lb. load

Measured centre-line temperature profiles from the Vespel®-lined bearing, just at the point of failure and shortly after the load was removed, are shown in Figure 21. Points of interest arising from these plots are as follows:

- The maximum recorded bearing temperature was approximately 110°C.
- At the time of the failure, a thermocouple in the brass housing, which was very close to the location of the maximum bearing temperature, recorded a temperature of about 90°C. However, by the time the load had been removed, this temperature had quickly risen to 110 °C (the same temperature as the bearing).
- At the time of the failure, the maximum temperature was recorded by the thermocouple located approximately 155 ° from the load line.

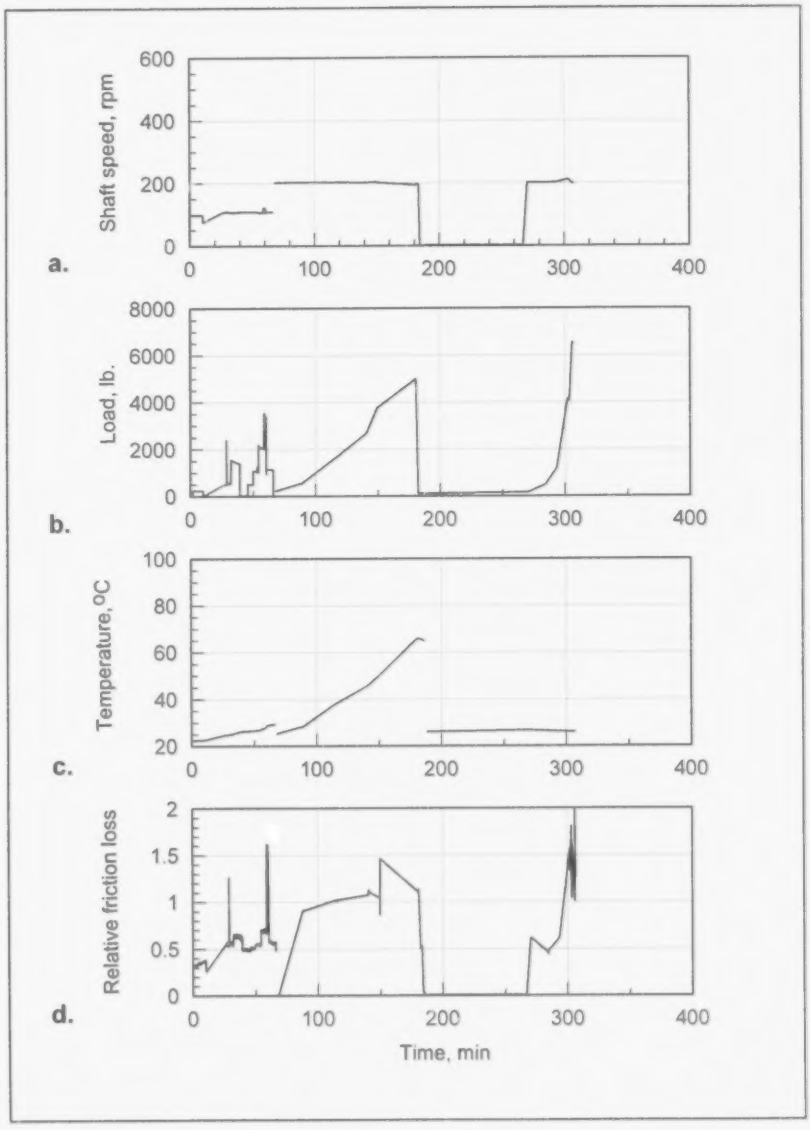
Figure 22 **Test results: Mark 2 Vespel®-lined bearing (original clearance)**
a. shaft speed **b.** bearing load
c. maximum bearing temperature **d.** relative friction loss

The measured test data are illustrated in Figure 22 (friction loss is related to that for the load of 4000 lb.).

In the course of each of these tests, very heavy rubbing sounds were heard.

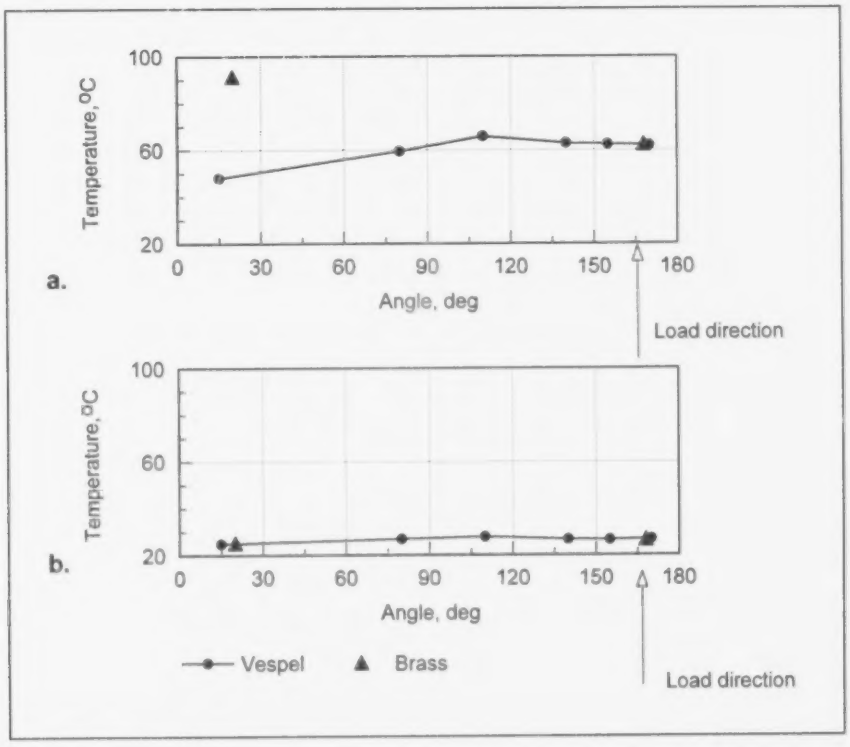
Measured bearing center-line temperature profiles from the first and second tests are shown in Figure 23.

Figure 23 **Centre line temperature profiles: Mark 2 Vespel®-lined bearing**
a. 200 rpm, 5000 lb. **b.** 100 rpm, 3500 lb.

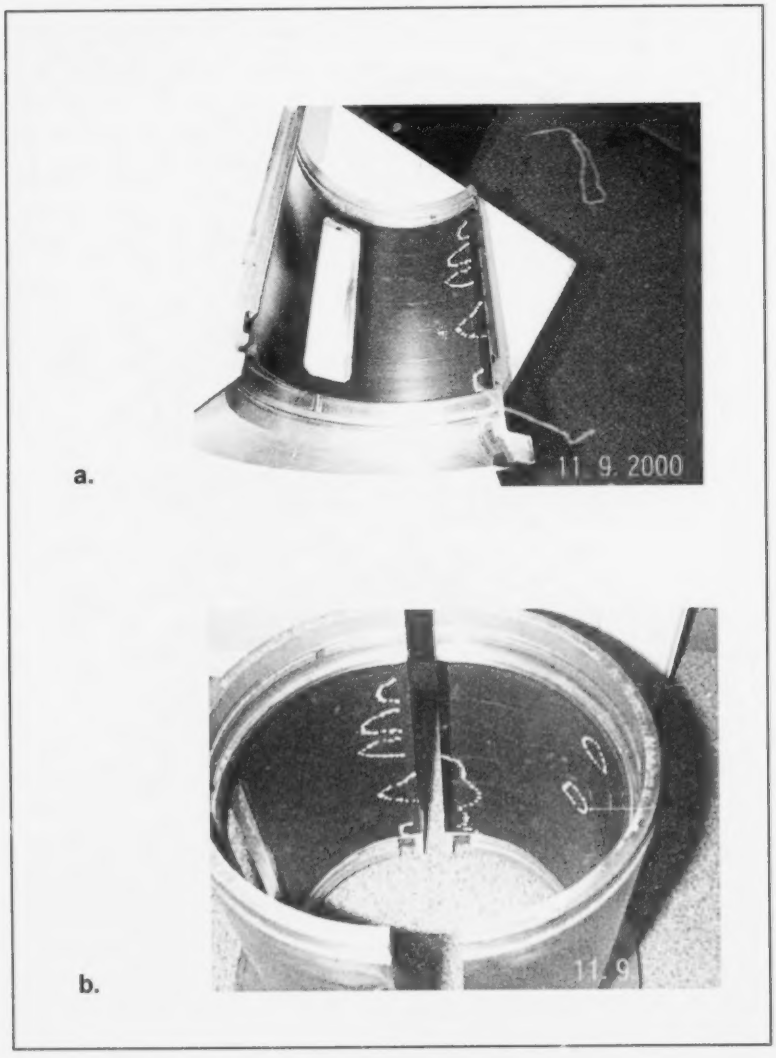
The bearing was removed from the rig and inspected. It was found that certain areas of the bearing bore had sustained quite heavy wear, as shown in Figure 24. The wear pattern became more clearly evident after the bearing had been machined and 0.005 in. was removed from the bearing bore. This damage is mainly confined to three major areas, as shown in Figure 25.

Figure 24 **Damage to the Mark 2 Vespel®-lined bearing prior to rebore**
a. bottom half **b.** top half

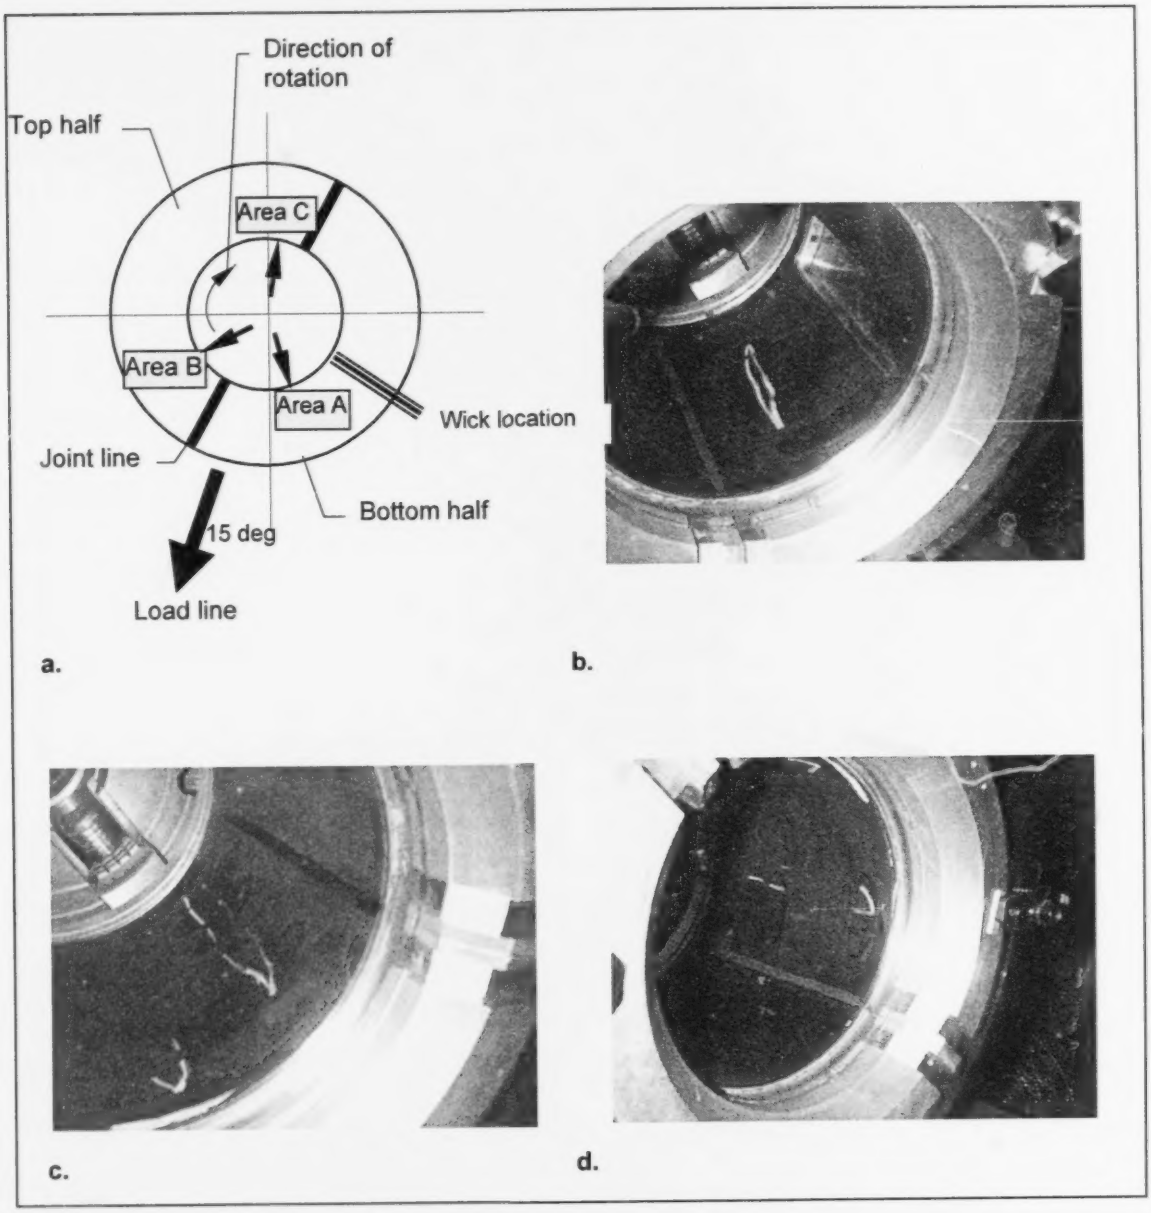
Figure 25 **Damaged sites (after 0.0025 inch machining operation): Mark 2 Vespel®-lined bearing**

a. damaged sites **b.** area A
c. area B **d.** area C

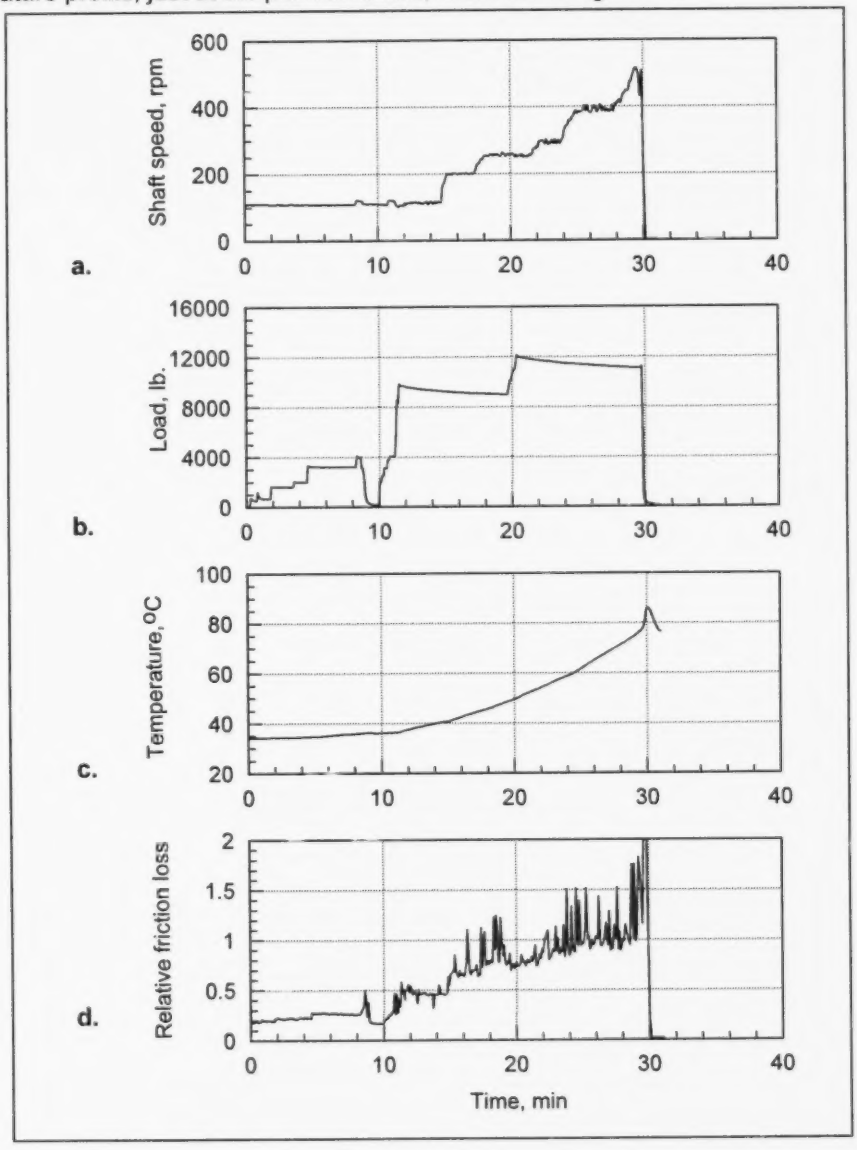
The re-machined bearing was reinstalled in the test rig, and attempts were made to bring the bearing up to the first test condition (538 rpm/16,100 lb.). After approximately 30 min of operation, when the load had reached approximately 12,000 lb. and the shaft speed was 500 rpm, smoke started to issue from the test bearing. At this time, the test was terminated. The results from this test are shown in Figure 26 (friction loss is related to that for the load of 12,000 lb.). It should be pointed out that quite significant rubbing sounds were heard during the course of this test. The measured bearing centre-line temperature profile, just at the point of failure, is shown in Figure 27.

Figure 26 **Test results: Mark 2 Vespel®-lined bearing (larger bore)**
a. shaft speed **b.** bearing load
c. maximum bearing temperature **d.** relative friction loss

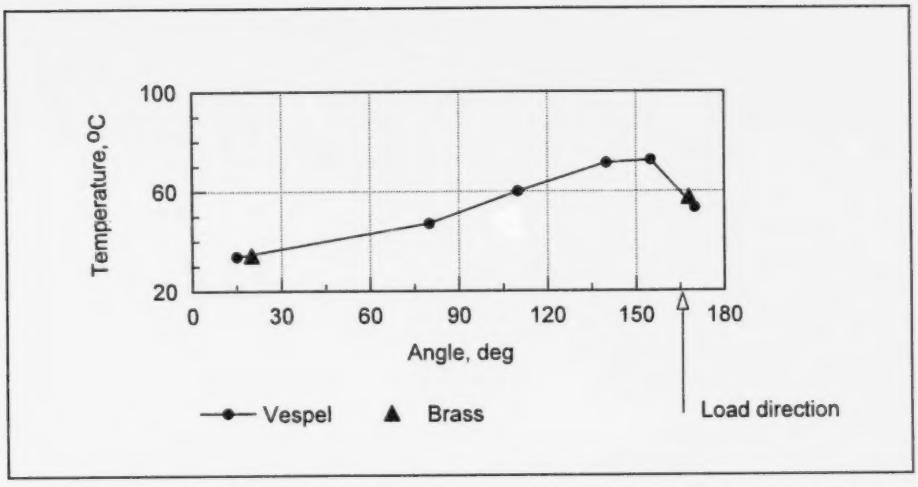
Figure 27 **Centre line temperature profile at point of failure 500 rpm, 11,000 lb. load: Mark 2 Vespel®-lined bearing (larger bore)**

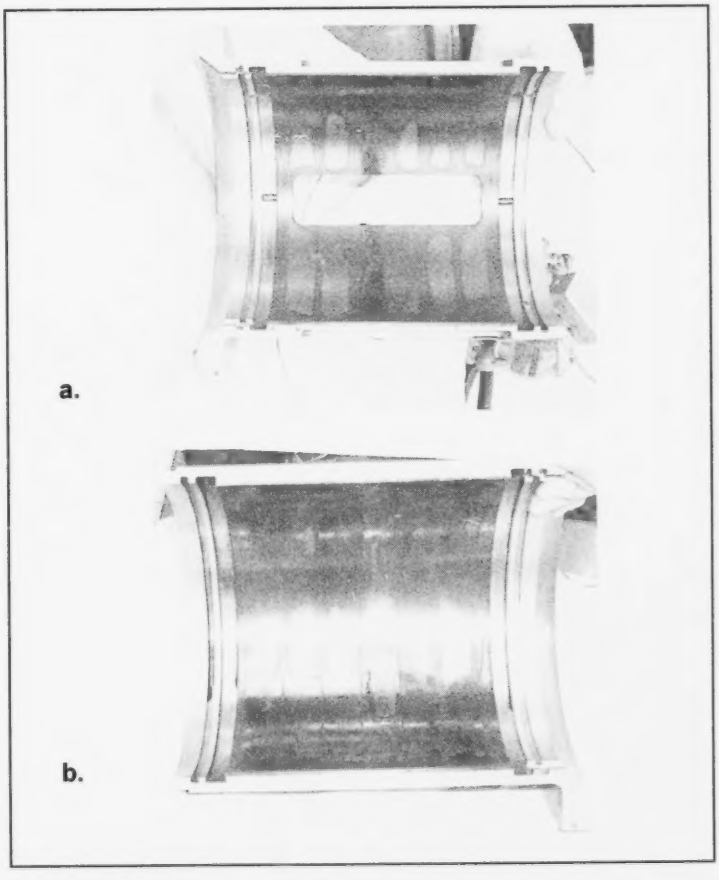
Figure 28 **Damaged Mark 2 Vespel®-lined bearing (larger bore)**
a. bottom half **b.** top half

The bearing was removed from the test rig. Photos showing the damaged Mark 2 Vespel®-lined bearing are presented in Figure 28. The wick and shaft after this test are shown in Figure 29.

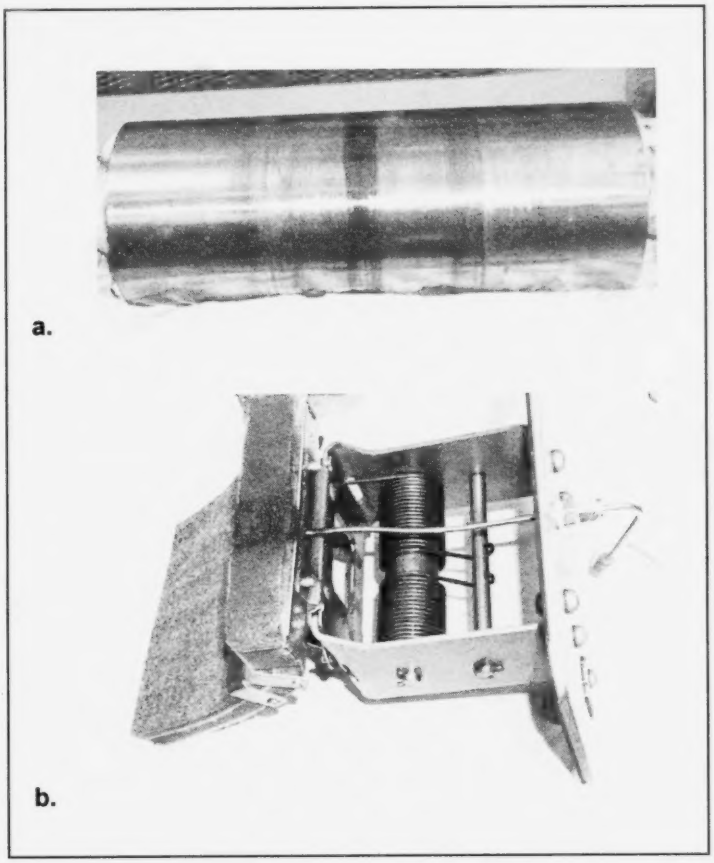
Figure 29 Damaged Mark 2 Vespel®-lined bearing (larger bore)
a. shaft **b.** wick

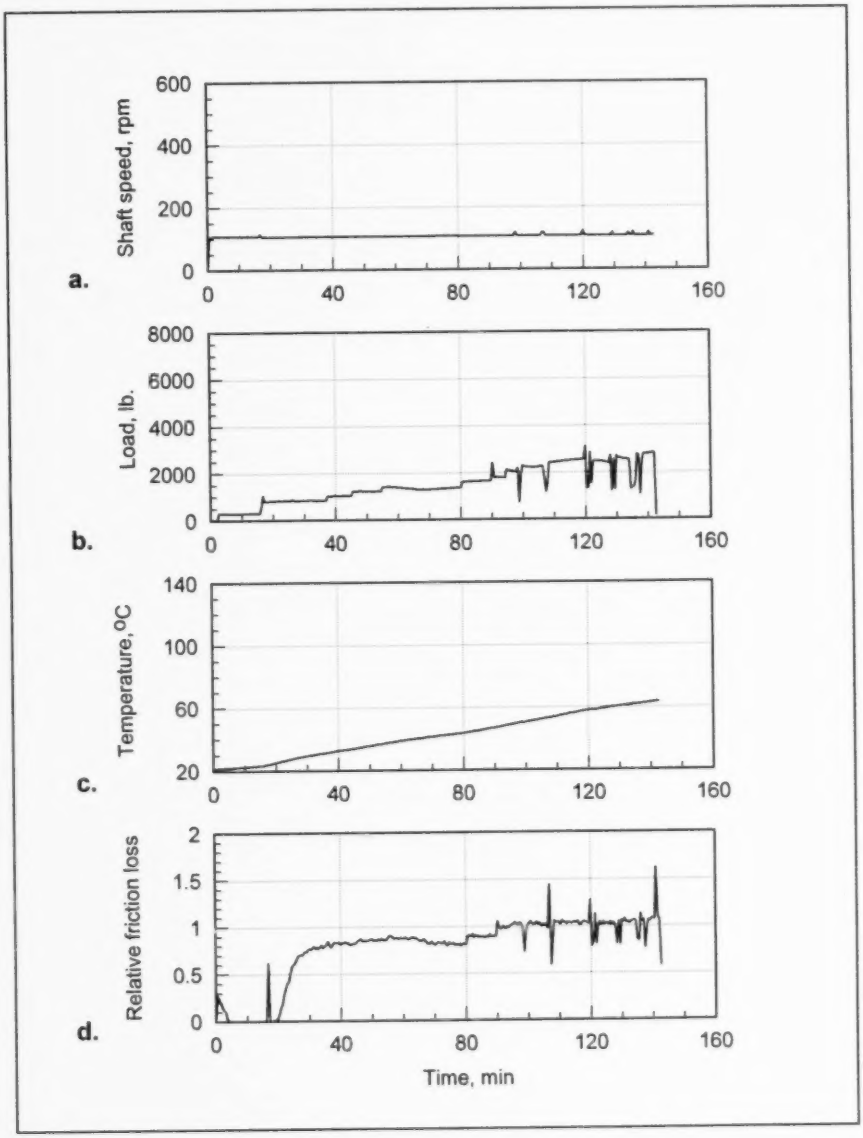
Figure 30 **Test results: Mark 3 Vespel®-lined bearing**
a. shaft speed **b.** bearing load
c. maximum bearing temperature **d.** relative friction loss

In the first series of tests on the Mark 3 bearing the rig ran at the lowest speed conditions, 106 rpm (223 ft/min). Over a time period of 143 min., the load was slowly incremented up to 2,800 lb. (42 psi) in approximately 200 lb. steps. At these conditions the strong rubbing noise and severe fluctuations of the measured friction torque were observed, similar to those observed in earlier tests. The maximum recorded bearing temperature in the Vespel® lining was 63°C. Figure 30 shows the recorded test results (friction loss is related to that for the load of 2,800 lb.).

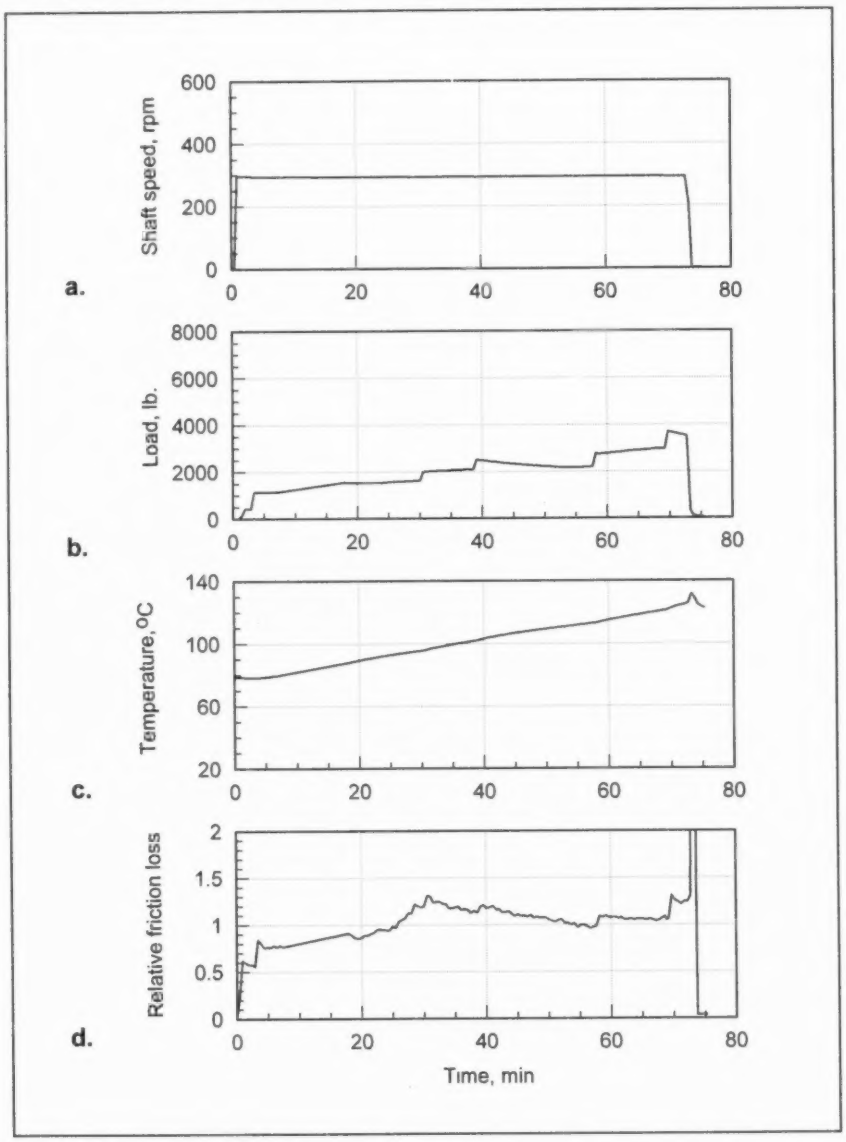
Figure 31 **Test results, shaft speed 295 rpm: Mark 3 Vespel®-lined bearing**
a. shaft speed **b.** bearing load
c. maximum bearing temperature **d.** relative friction loss

The tests on the Mark 3 bearing were also carried out at a speed of 295 rpm (621 ft/min). Figure 31 shows the recorded data for the last 70 min. of the test (friction loss has been related to the average for the load of 2,800 lb.). Over a period of 147 min. the load was slowly increased up to 3600 lb. At this load the bearing experienced sudden fluctuation of friction torque and soon seized.

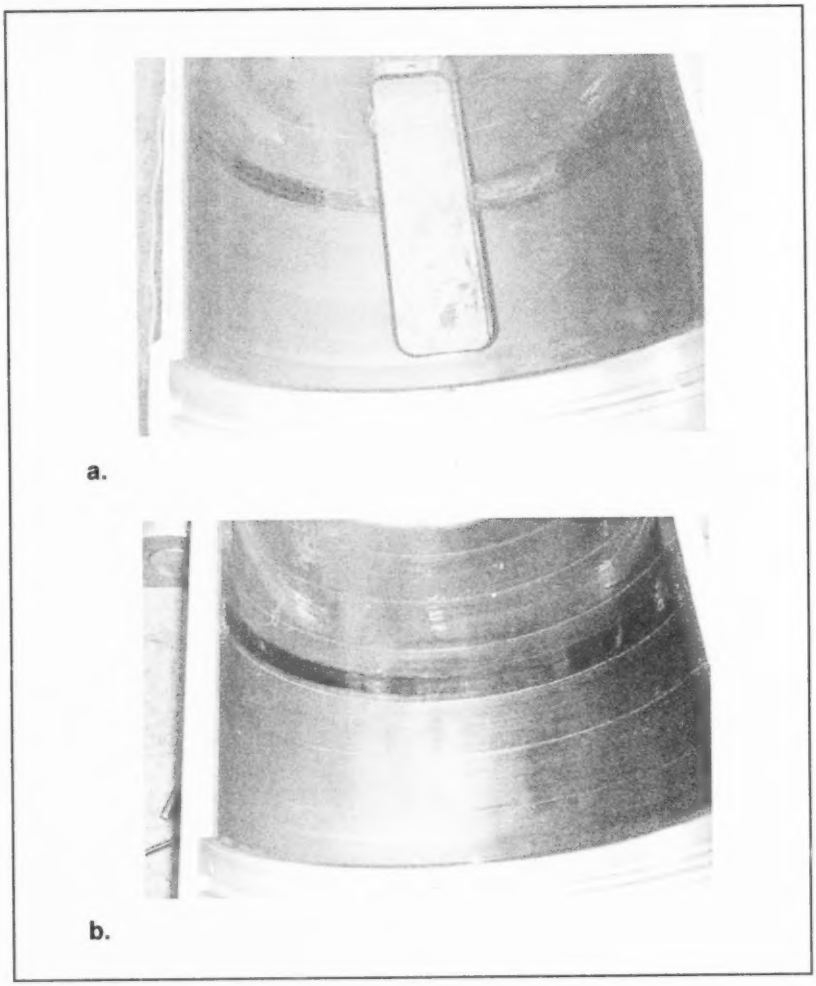
Damage to the bearing was consistent with that obtained in the previous tests, with wiping and heat cracking of the Vespel® lining (Figure 32). However, this time the damage was confined to the central portion of the bearing lining, with width of the wiped area varying between 1 and 1.5 in., and the wiping extended a full 360° around the bearing. It is likely that such damage occurred due to the tighter bearing clearance.

Figure 32 **Damaged Mark 3 Vespel®-lined bearing**
a. bottom half **b.** top half

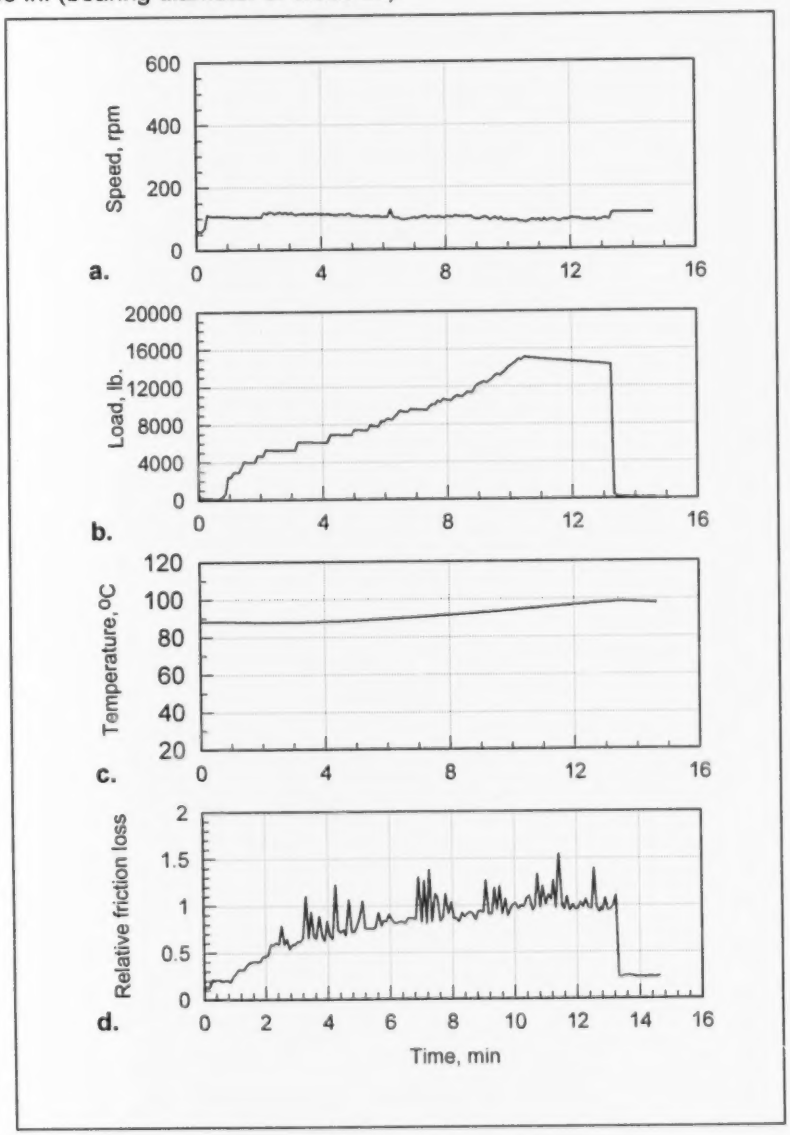
Figure 33 **Test results: Mark 4 Vespel®-lined bearing**
a. shaft speed **b.** bearing load
c. maximum bearing temperature **d.** relative friction loss

At 106 rpm this version of the bearing achieved a load of 15,000 lb., which was the highest load applied to Vespel®-lined bearing. Figure 33 illustrates the course of this test (friction loss is related to the average loss for the load of 15,000 lb.).

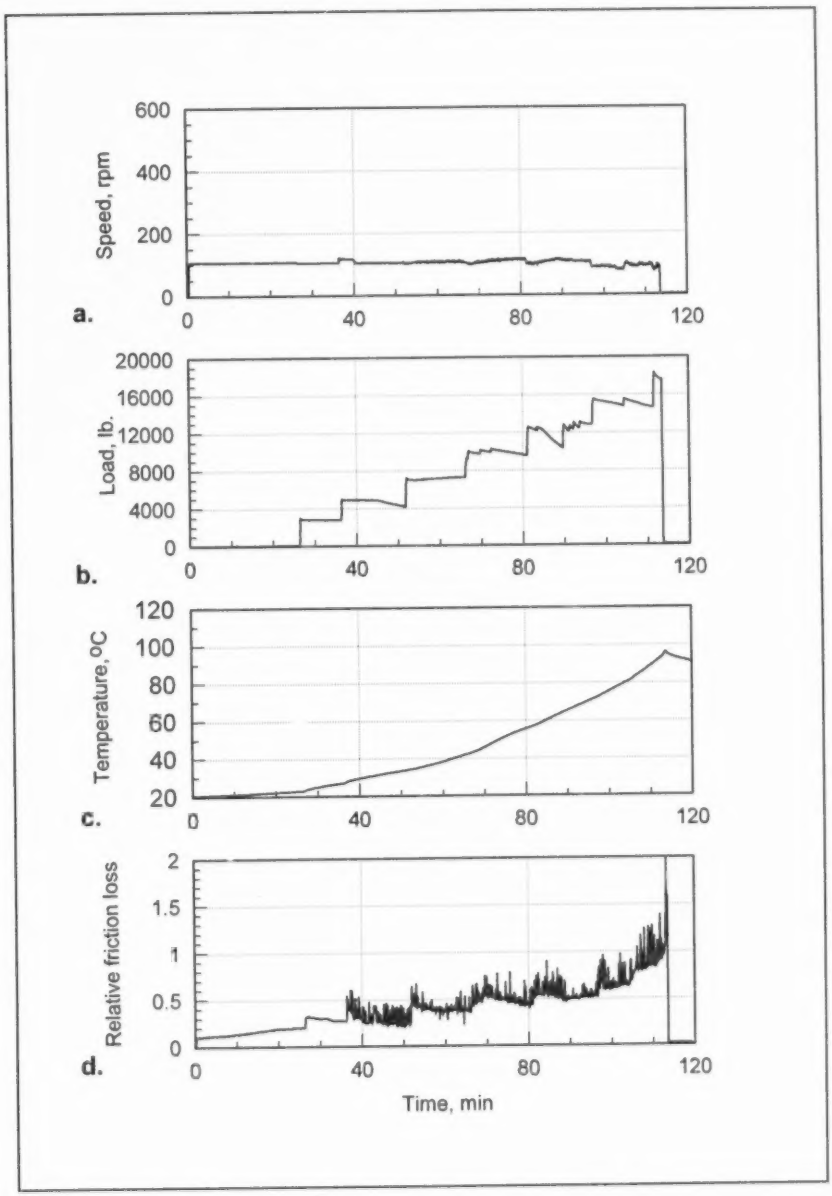
Figure 34 **Test results. Mark 4 Vespel®-lined bearing failure**
a. shaft speed **b.** bearing load
c. maximum bearing temperature **d.** relative friction loss

However, an attempt to run this bearing with a load of 18,200 lb. was unsuccessful (Figure 34, friction loss related to that for 15,000 lb.). The bearing was damaged, and the pattern of failure was the same as that observed in the previous tests. Figure 35 shows the damaged Mark 4 bearing.

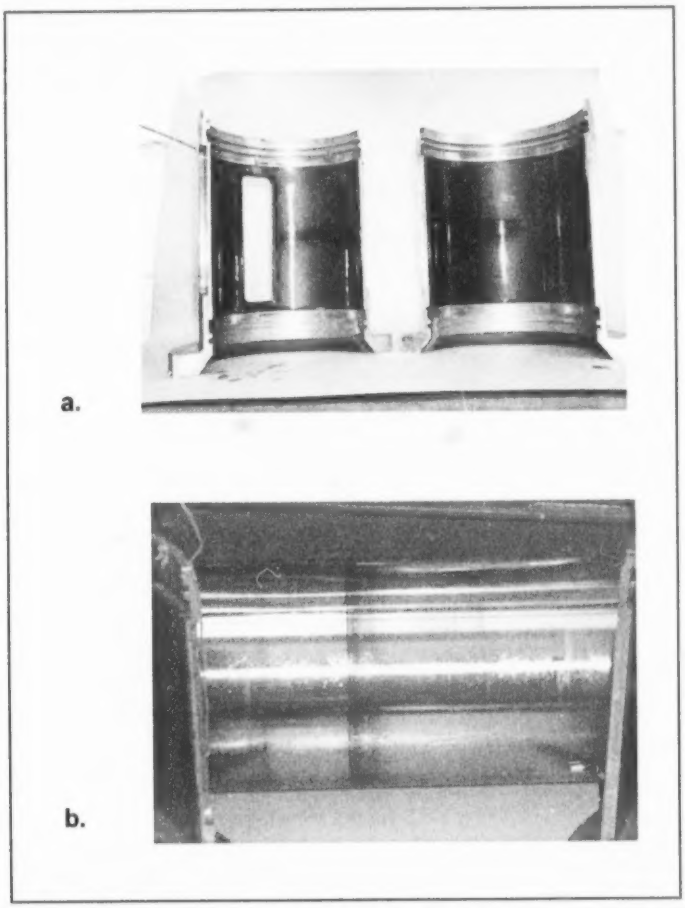
Figure 35 **Mark 4 Vespel®-lined bearing and shaft after the tests**
a. bearing **b.** shaft
